HMS VANGUARD 100

SURVEY 2016-2017

Survey Report

Emily Turton, David Crofts, Dr Clare Fitzsimmons, Prof Chris Rowland, Prof Kari Hyttinen, Simon Kay, Lt Jen Smith, Bob Anderson, Marjo Tynkkynen, Kieran Hatton, Dr Joanna Porter, Ben Wade

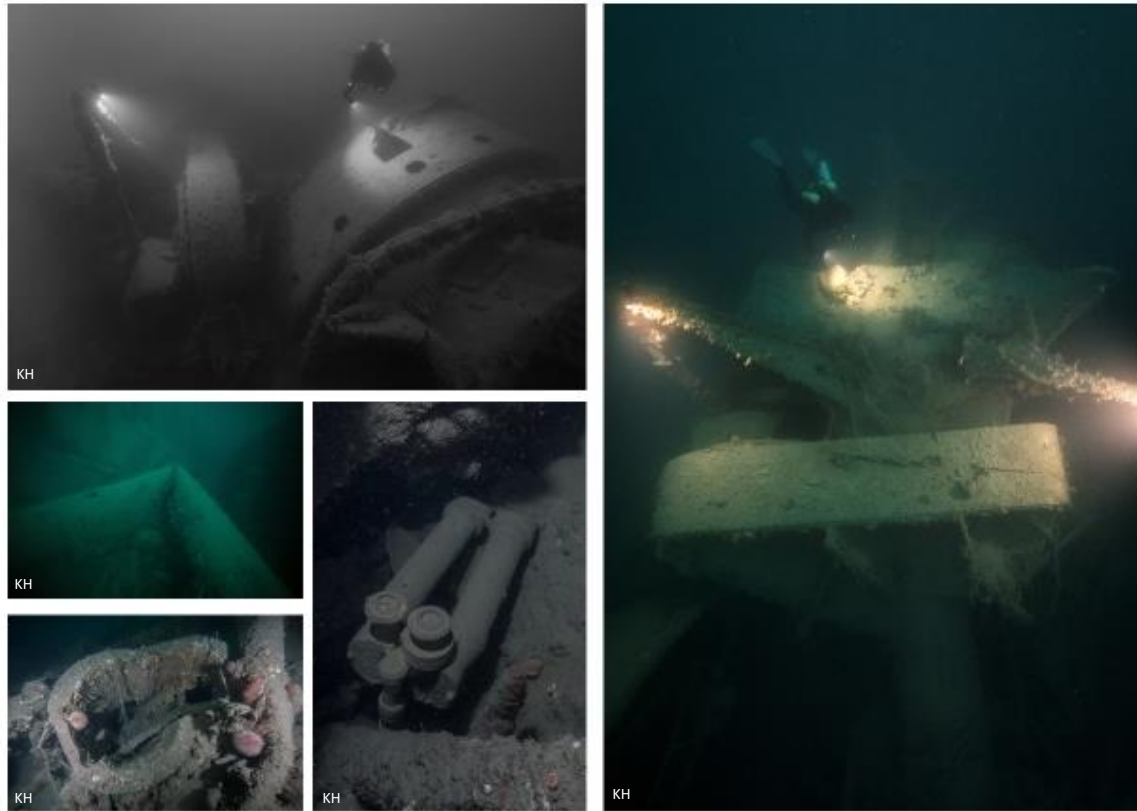
Figure 28: Clockwise from top left: A Turret and spotting top, foremast bent at 90 degrees, forward torpedo tube door, periscope binoculars, spotting top

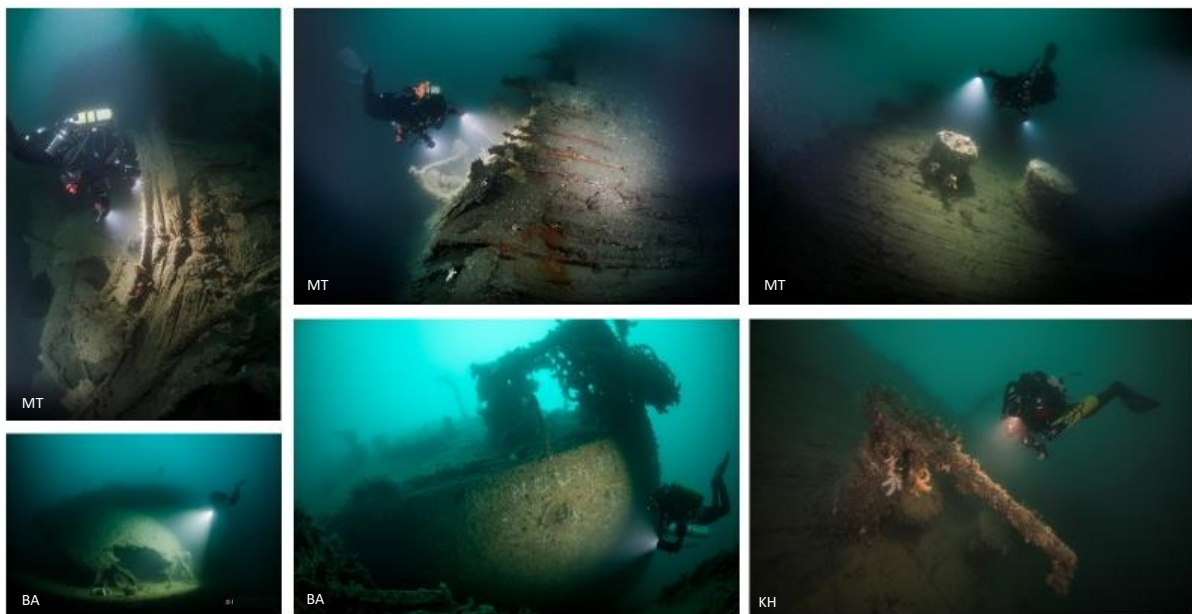
aperture at the “break” in the hull. This bent section of upper decking contains a distinctive curved edge, that is almost certainly the deck aperture for Y Turret barbette (frame 200). Adjacent to this, Y Turret sits upright on the seabed. The gun house and barrels are missing. On the seabed sits the only 12-inch barrel located during the survey. It shows signs of salvage – the barrel is broken and the base of the barrel is stuck in the seabed, but has salvage chains wrapped around it. X Turret sits 10m to the northwest from Y Turret. It is also upright with gun house and barrels missing. The turret has been displaced from its original position forward of the turbine rooms.

Figure 38: Y Turret teak deck ring; 90 degree snapped deck; identifying capstan and vent at snapped stern section; torpedo salvage hole; stern name lettering; Hotchkiss gun

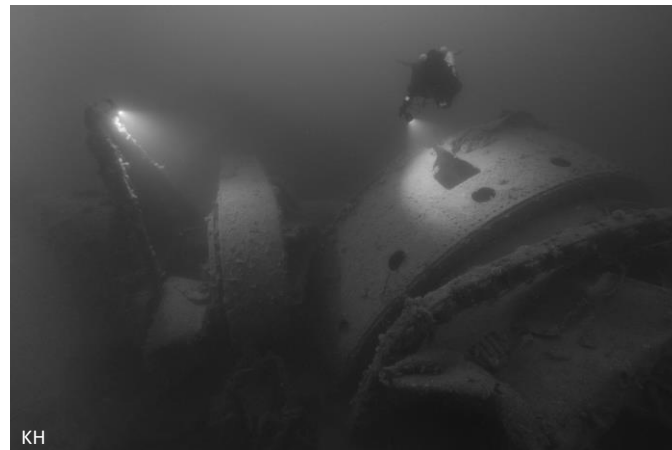
Figure 39: A Turret

A Turret is located in the A Turret & Bridge wreckage on its side on top of other wreckage. The barbette is broken open to reveal the training rack. A Turret lies approximately 15m due east of the current position of the bow.

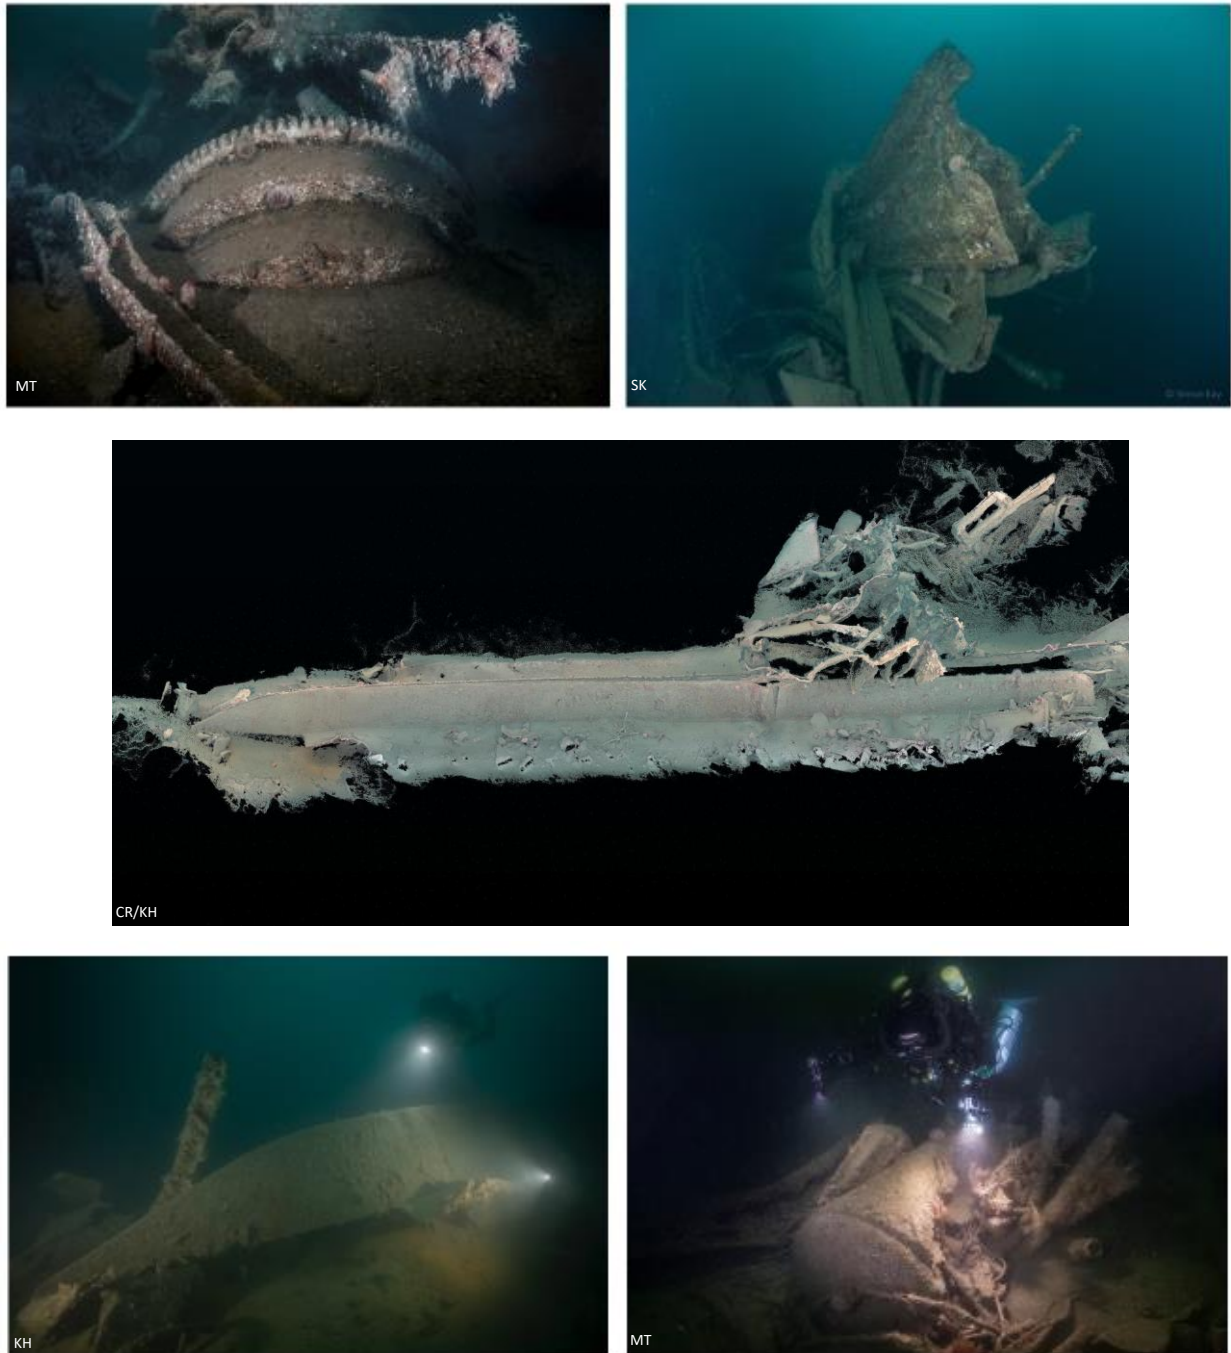
This area is characterised by a large amount of scattered and broken debris, mainly consisting of twisted steel plating and pipes. Most of the debris is small in size, although there are two larger sections located 20-25m east of the datum line. One of these sections contains a magazine hoist trunk and revolving shell bogie, likely associated with Q Turret. To the east of the datum line there is a section of ship's hull, approximately 30m in length, orientated east/west, with 22.3m of bilge keel including the tapered forward end. This is almost certainly from the starboard hull, between A Turret and Q Turret, having been thrown here by the force of the explosion. In addition, two boilers (survey numbers 9, 10) are located in this area. Both of these boilers show compression damage consistent with an explosion.

Figure 44: NE wreck site wreckage. Top: Q Turret shell bogie upper rack; Q Magazine hoist trunk. bottom: starboard side forward bilge keel; 3D image of bilge keel wreckage; Boiler 10 showing compression damage

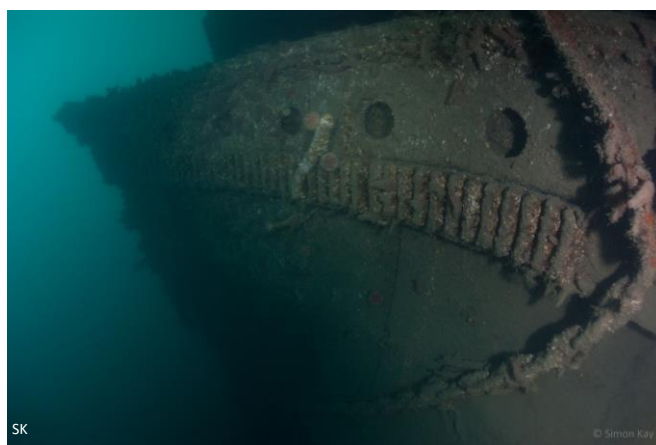
Figure 93: A Turret training rack in the broken open ring bulkhead
